LDEF M&D SIG SUPPORT

Final Report

THE MAGNITUDE OF IMPACT DAMAGE ON LDEF MATERIALS

Martha Allbrooks and Dale Atkinson  
POD Associates, Inc.  
2309 Renard Place, S.E.  
Suite 201  
Albuquerque, New Mexico 87106

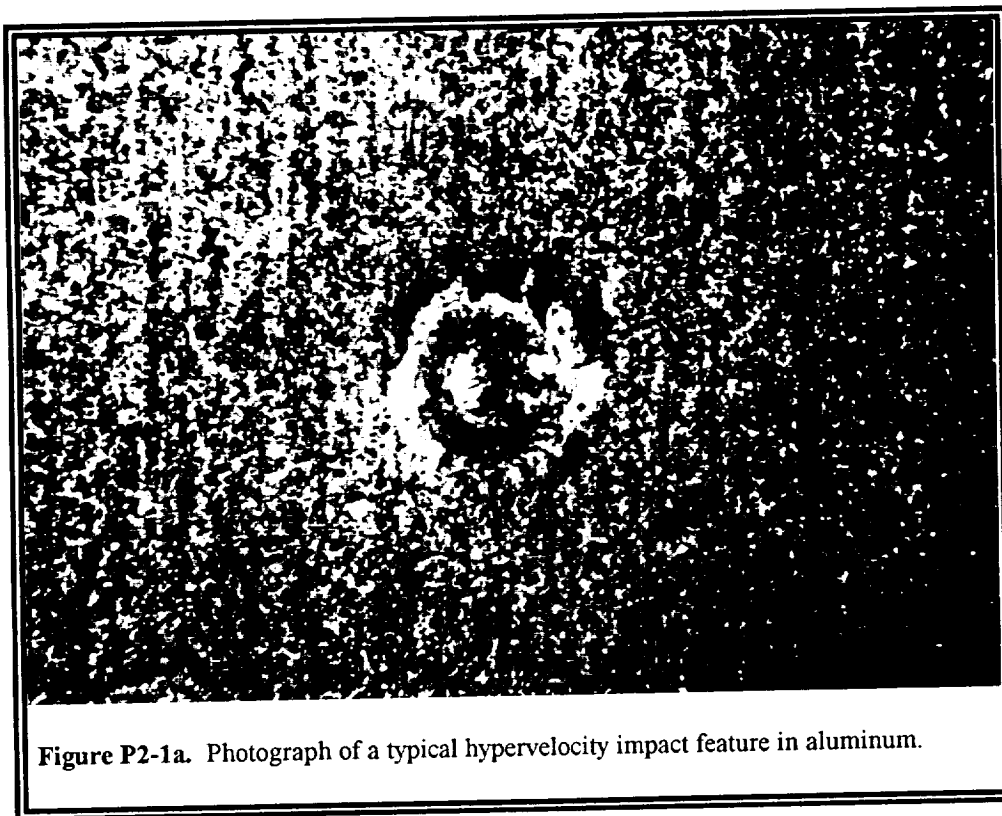
**Figures P2-1a and P2-1b (S90-44982 and KSC-390C-2038.4)** are typical of hypervelocity impacts into aluminum surfaces. Figure P2-1a shows an impact which has a symmetrical hemispherical crater characteristic of all impacts into aluminum surfaces. Here the typical symmetrical lips stand above the surface of the aluminum. Figure P2-1b is a picture of the back surface of the S0001/A0189/A0172 experiment tray, located at LDEF Bay D02, showing the spallation (removal) of black paint caused by a front surface impact. Spalled material can cause additional internal damage to satellite components or become a contamination source, as described later in Section 2.5.

**Figure P2-1a.** Photograph of a typical hypervelocity impact feature in aluminum.

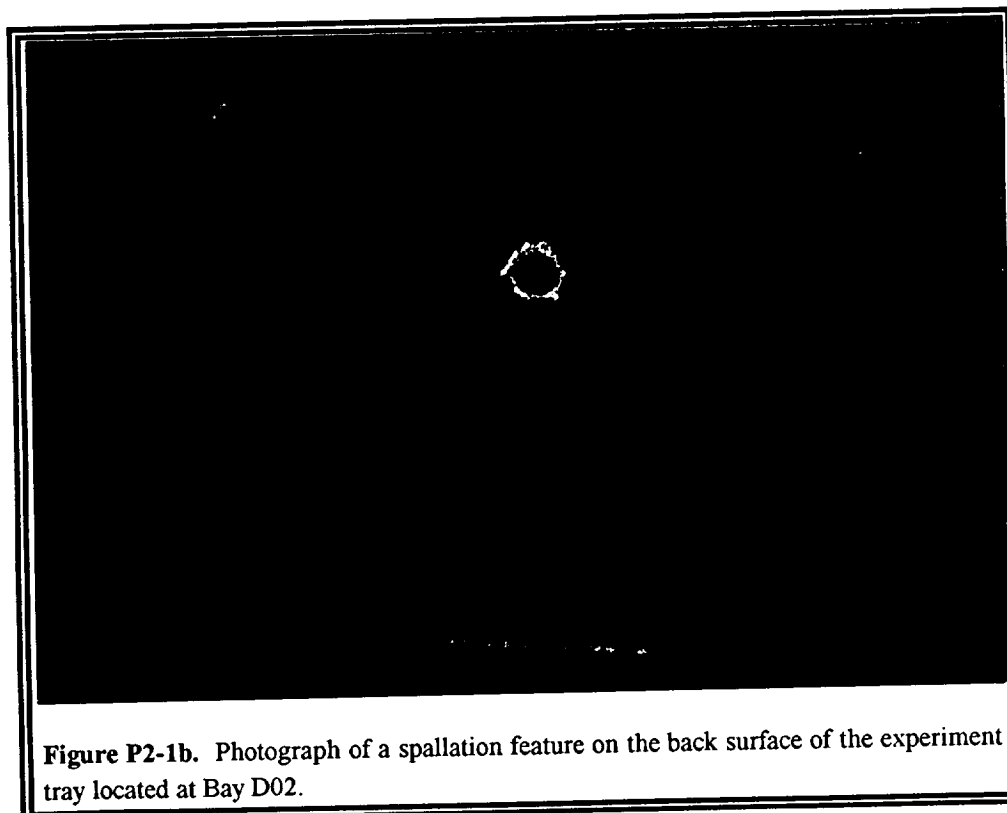
**Figure P2-1b.** Photograph of a spallation feature on the back surface of the experiment tray located at Bay D02.

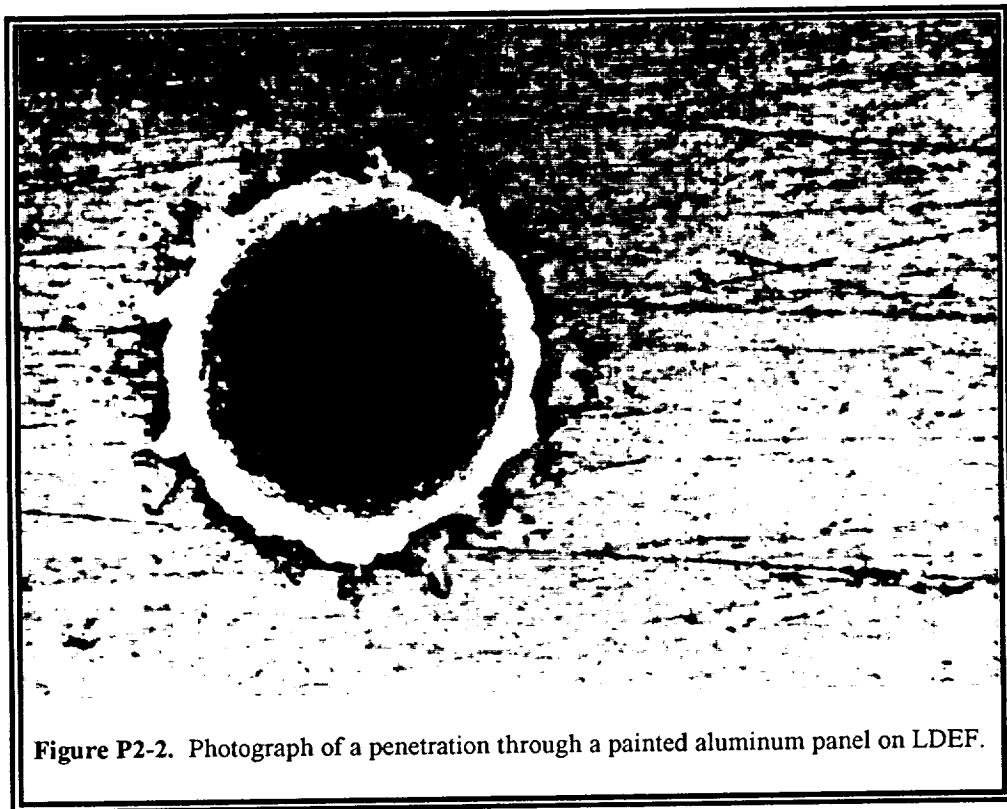
**Figure P2-2 (S90-44980)** is a picture of a penetration through an aluminum panel on LDEF, and is typical of penetrations at hypervelocity speeds. It is a symmetrical penetration hole with lips which are also symmetrical. This feature is the back surface exit hole made by the impactor through the aluminum. The front surface (opposite side of this plate) of this feature is a penetration through a painted aluminum plate. A picture and discussion of the front surface of this feature is included in Section 2.2.2 under Figure P2-38. These types of penetrations provide

**Figure P2-2.** Photograph of a penetration through a painted aluminum panel on LDEF.

a substantial amount of secondary ejecta and an expanding debris cloud of solid, liquid, or gaseous particulates which can cause damage to other materials located immediately behind the surface. Loading pressures on internal components located approximately an inch away from the penetration could approach as much as 50 kilobars.

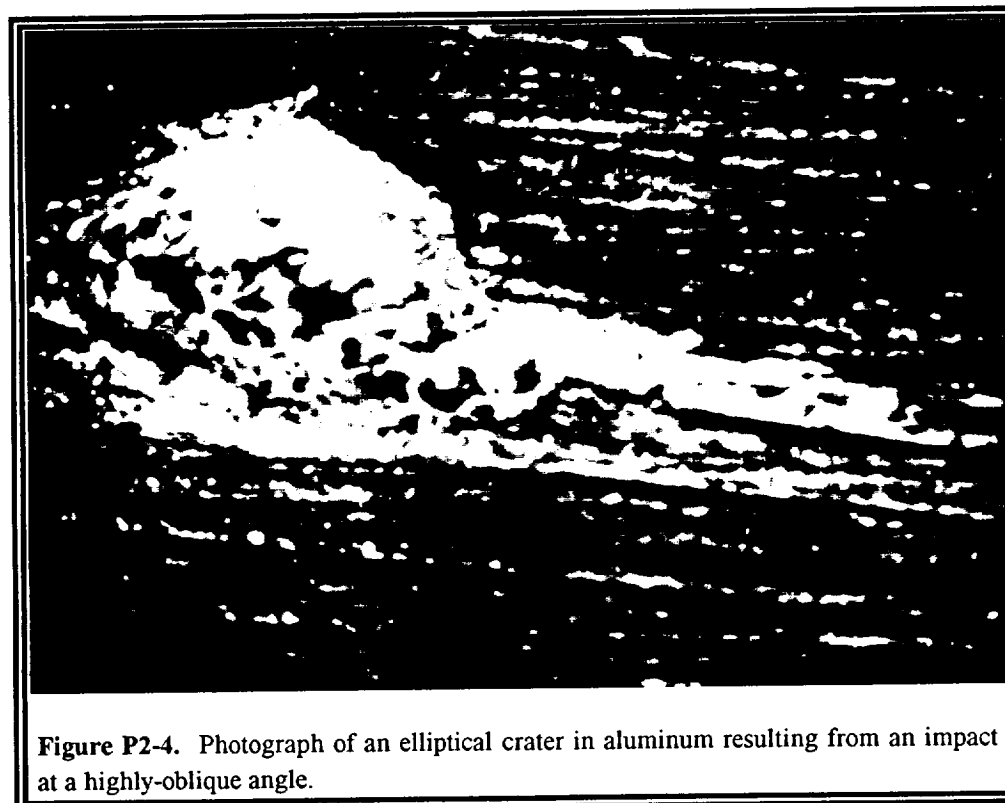
**Figure P2-4.** Photograph of an elliptical crater in aluminum resulting from an impact at a highly-oblique angle.

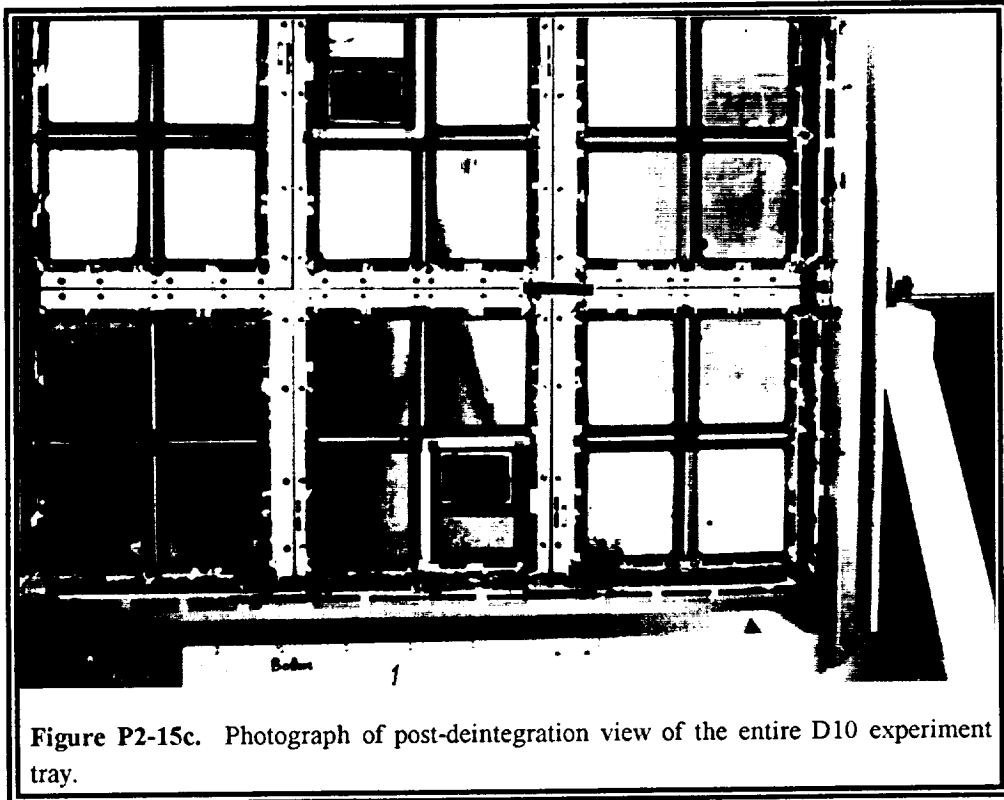
Figure P2-15c. Photograph of post-deintegration view of the entire D10 experiment tray.

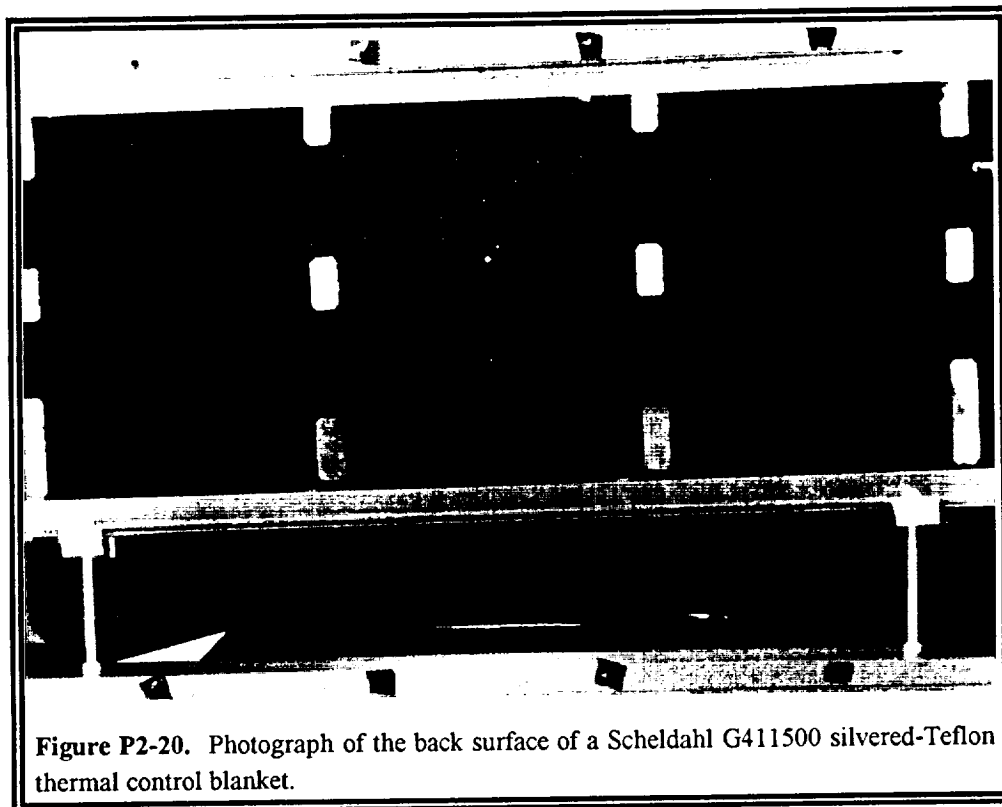
**Figure P2-20.** Photograph of the back surface of a Scheldahl G411500 silvered-Teflon thermal control blanket.

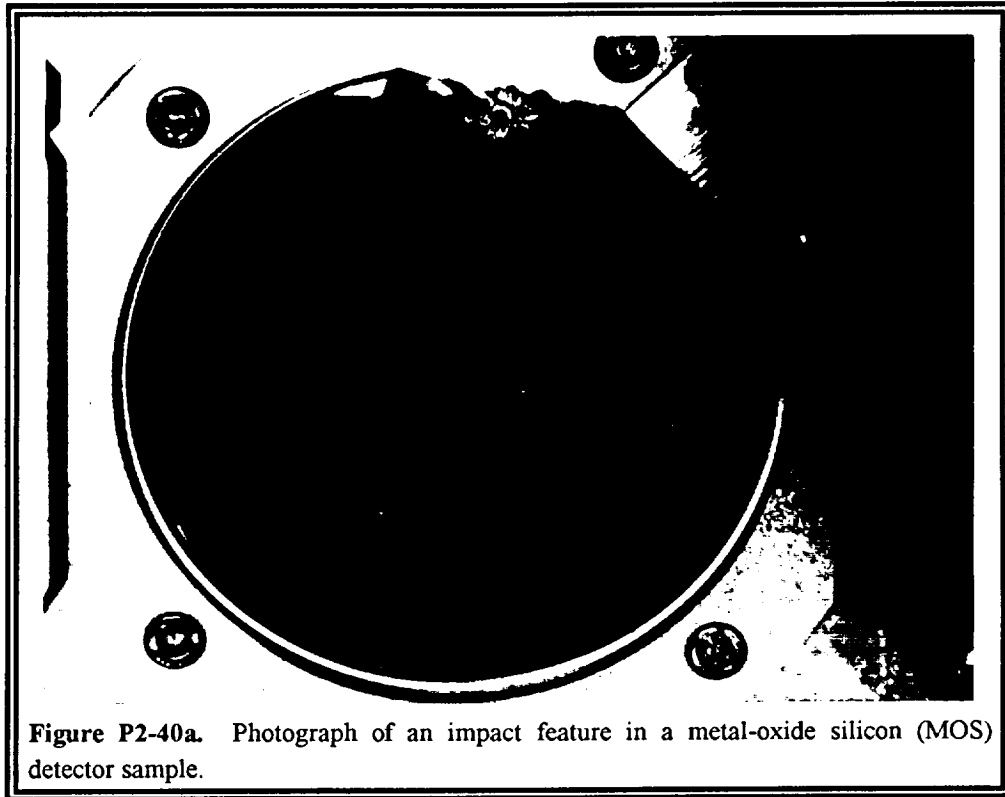
**Figure P2-40a.** Photograph of an impact feature in a metal-oxide silicon (MOS) detector sample.

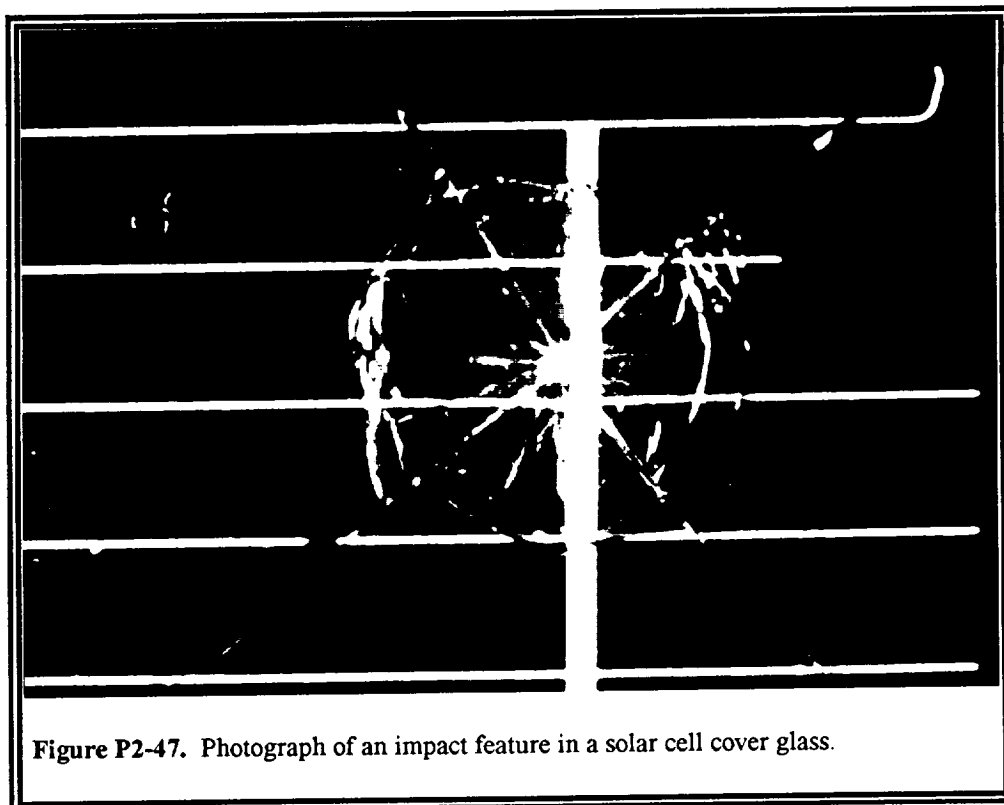
**Figure P2-47.** Photograph of an impact feature in a solar cell cover glass.

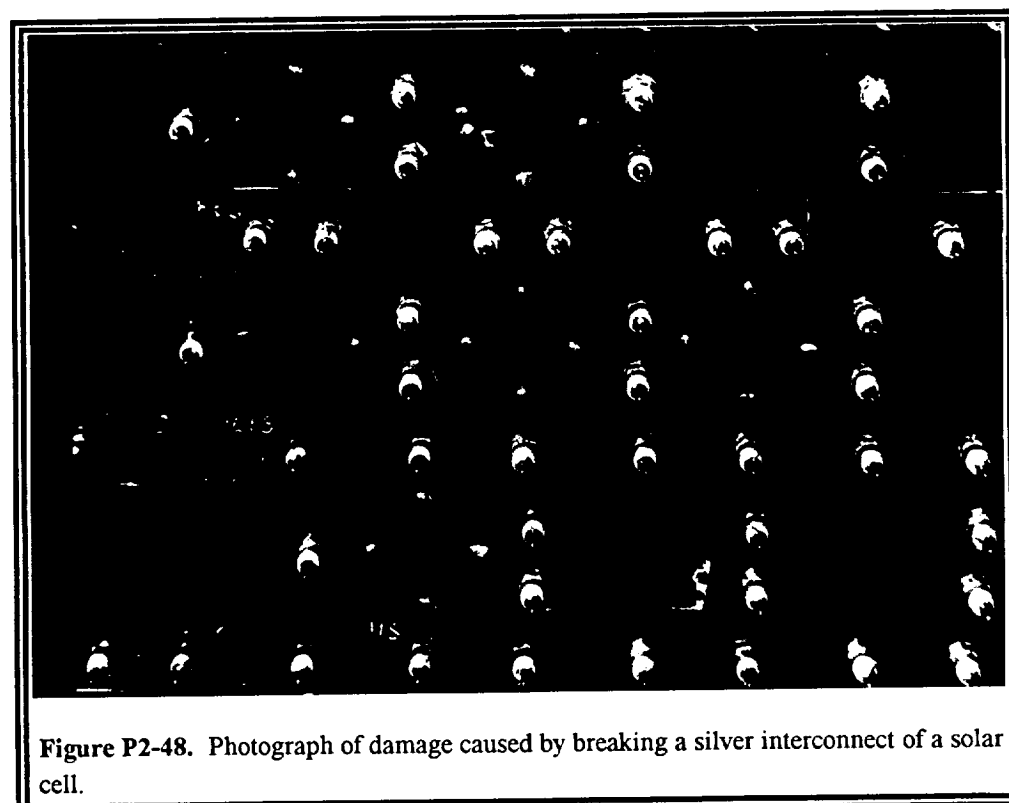
**Figure P2-48.** Photograph of damage caused by breaking a silver interconnect of a solar cell.

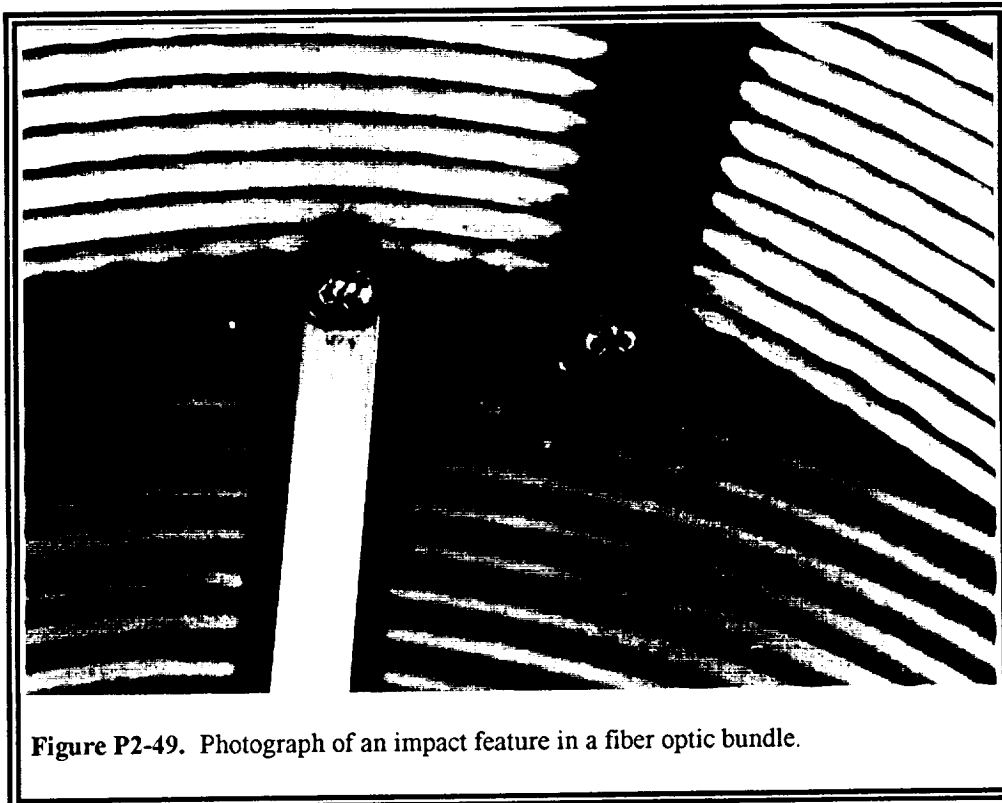
**Figure P2-49.** Photograph of an impact feature in a fiber optic bundle.

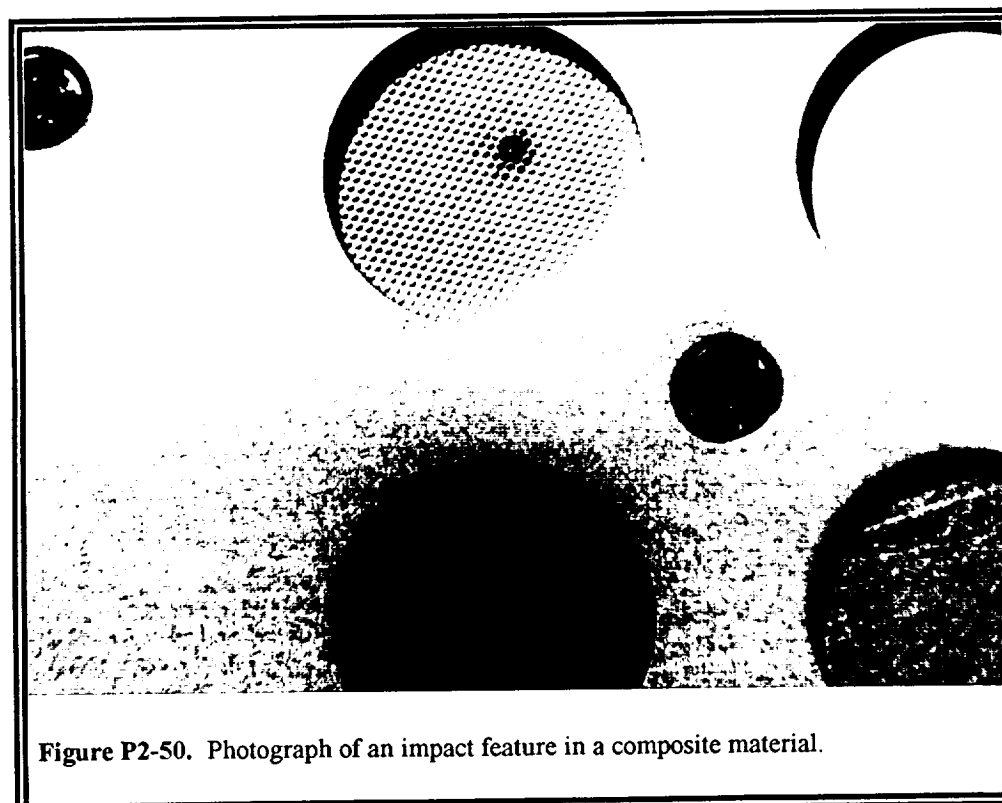
**Figure P2-50.** Photograph of an impact feature in a composite material.

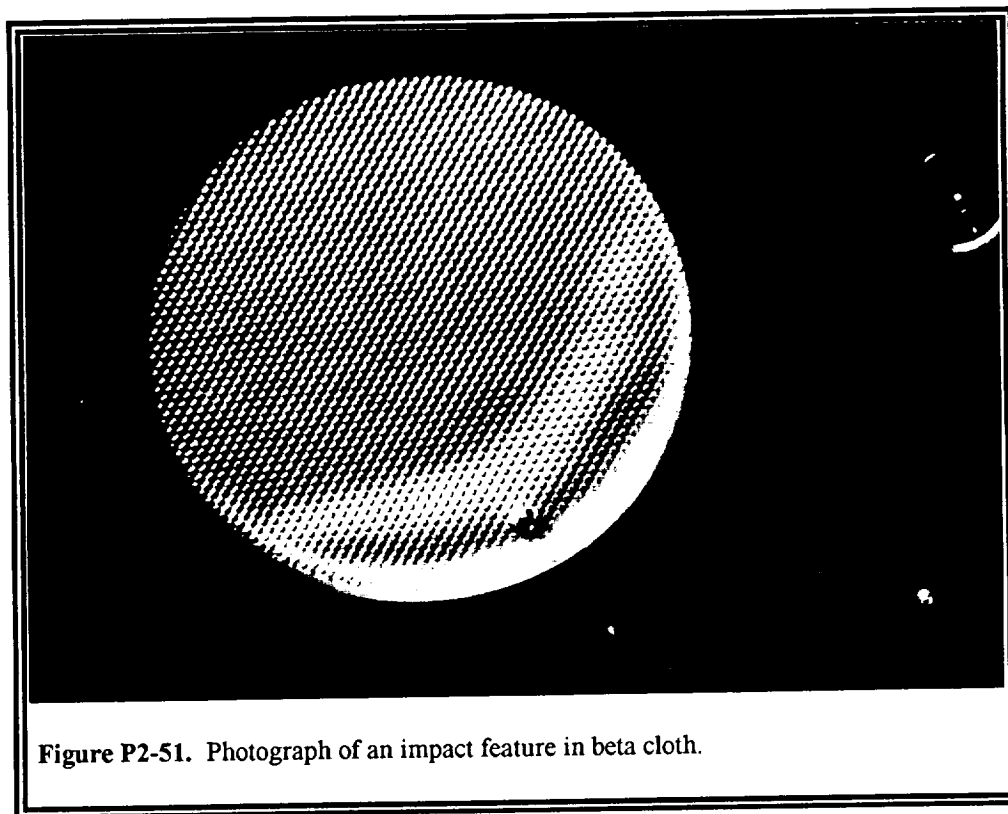
**Figure P2-51.** Photograph of an impact feature in beta cloth.
